Collection of Data on Fire and Collapse, Faculty of Architecture Building, Delft University of Technology

Abstract: On May 13, 2008 a sizeable portion of the Faculty of Architecture Building at Delft University of Technology (TUD) collapsed following a fire. This is significant in that collapse of reinforced concrete buildings due to fire is rare. In order to facilitate analysis of this fire and collapse, the research team met with TUD personnel, fire fighters, eyewitnesses, and government researchers to collect data of scientific importance, including digital recordings of the event, structural plans, material specifications, architectural layout, data on building systems, information on contents, fire safety management procedures, and response of the occupants and fire fighters.

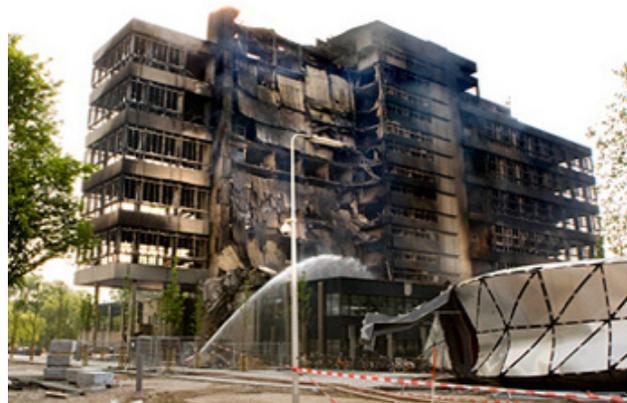
Fig. 2. Photograph of Faculty of Architecture Building, TUD, following fire and partial collapse [2].

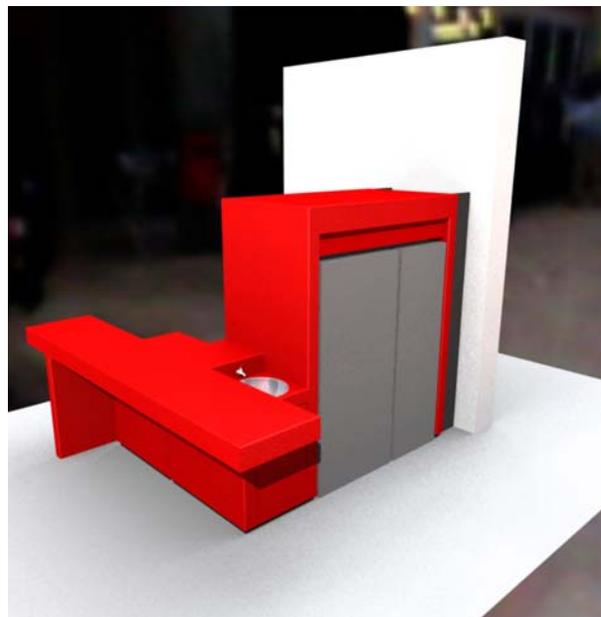
Fig. 5. Rendering of pantry area where coffee vending machine (source of fire ignition) was located within the Faculty of Architecture building [10].

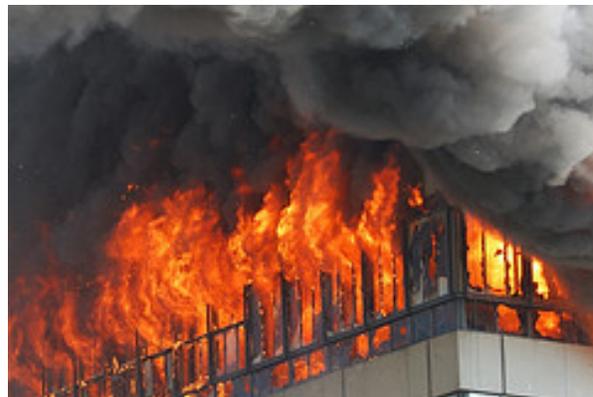
Fig. 6. Photograph of intense burning during fire [2].

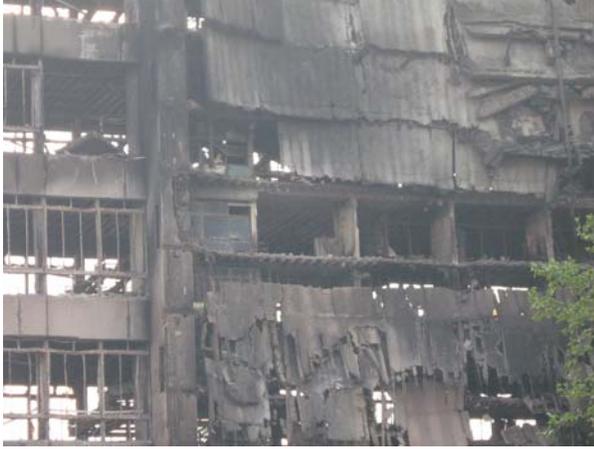
Fig. 7. Photograph of collapse area [11].
